**CHISAGO COUNTY  
COURT HOUSE**

# St. Croix Valley Healthy Waters Initiative

## Chisago County Government Center

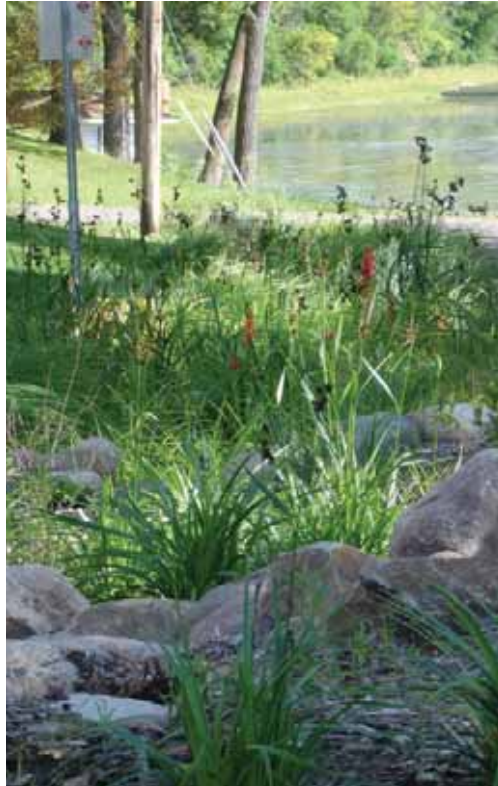
NORTH LAKE STREET INFILTRATION SWALE

The three photos depict the different BMPs used throughout the site to capture rain water as well as reduce turf mowing and irrigation needs. The infiltration swale (left) was installed along North Lake Street to create better infiltration for water flowing off the road. The Sheriff's rain garden (bottom right) also helps reduce stormwater runoff by diverting the flow towards the depression instead of the nearby drain. Finally, the woodland planting (top right), reduces mowing and irrigation needs around the property as well as restores a portion of the native shoreline vegetation.
